10. EAGLE TURIN (at times referred to as "vessel") is a Singapore flagged crude oil tank vessel, assigned IMO No. 9360465, and having the following principle dimensions: 809.7 feet length; 137.7 feet beam; and 69.9 feet depth.

18. At the time of incident, August 5, 2020, the EAGLE TURIN was at the pilot boarding location in preparations to embark Captain Murray, for docking at an oil facility in the Port of New York and New Jersey, United States of America.

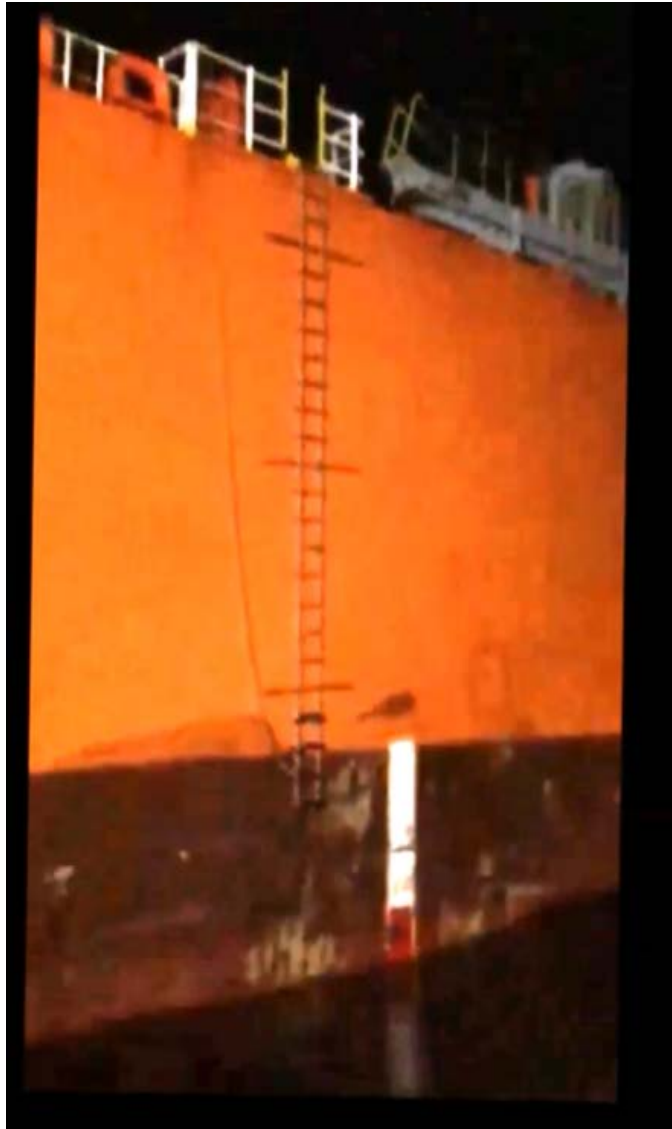
Image No. 1. EAGLE TURIN pilot ladder

25. Image No. 1, above, was taken from the launch boat YANKEE, minutes after the fatal incident (fall), while the launch boat AMERICA was heading with Captain Murray onboard to Staten Island, to obtain emergency medical treatment for Captain Murray.
26. U.S. Coast Guard summaries of crewmember interviews report that immediately before his fatal fall, Captain Murray was at or near the top of the pilot ladder depicted in Image No. 1, above.

37. EAGLE TURIN has a Pilot Line painted on her hull. The Pilot Line is the white vertical line with a red rectangle, towards the right of the pilot ladder, as which can be seen near the bottom of Image No. 1 above.

42. The significance of the Pilot Line is that if any part of the color “red” is showing, the ‘9 meter’ SOLAS limit has been exceeded, thereby preventing use of a pilot ladder and requiring a combination arrangement.
43. At the time the pilot launch AMERICA came alongside EAGLE TURIN, to permit Captain Murray to embark, the Pilot Line was displaying “red”, as can be plainly seen near the bottom of Image No. 1 above.
44. EAGLE TURIN did not provide a combination arrangement for Captain Murray’s embarkation, negligently causing and/or contributing to Captain Murry’s falling from the vessel as he attempted to board the vessel via the provided pilot ladder.
